### Dye Interaction with Rising Bubbles in a Crossflow

Crepeau, J. C.<sup>1)</sup> and McIlroy, Jr., H. M.<sup>1)</sup>

1) Department of Mechanical Engineering, University of Idaho, P.O.Box 50776, Idaho Falls, Idaho 83405, USA

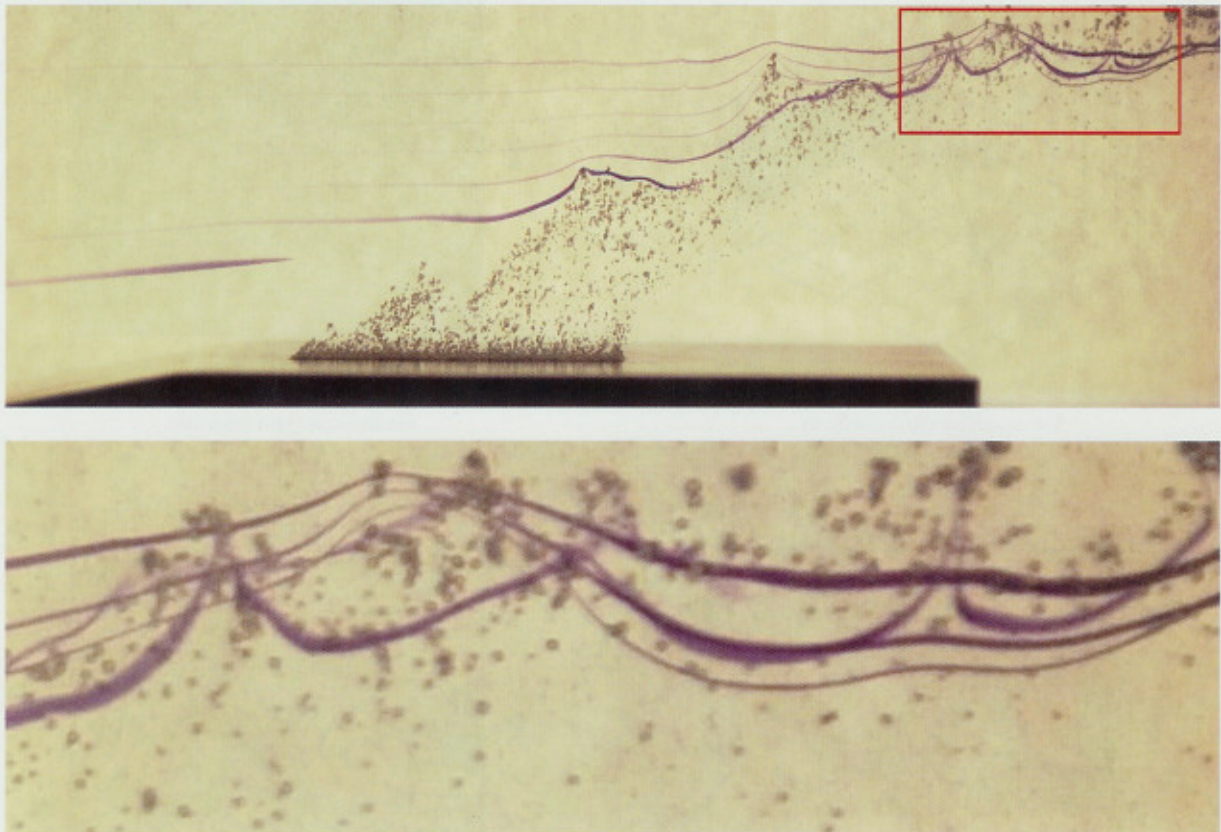
The figure shows the interaction between rising bubbles and dye injected upstream. The bubbles are created by a reaction between the working fluid (a mixture of hexanoic acid and mineral oil) and sodium embedded in a nonreacting metal plate. The Reynolds number is 350, based on the length of the duct. Along the leading edge of the bubbles, one observes a billowing effect, due to the deformation of the boundary layer profile caused by the rising bubbles and the subsequent growth of the Kelvin-Helmholtz instability. In the closeup, the bubbles interact both in groups and individually with the dye filaments. This work was funded by a grant from the U.S. Department of Energy, Environmental Management Science Program.
